Optical Disc Archive Software Ver 5.5.3 is released.

[Additional Items in Ver5.5.3]

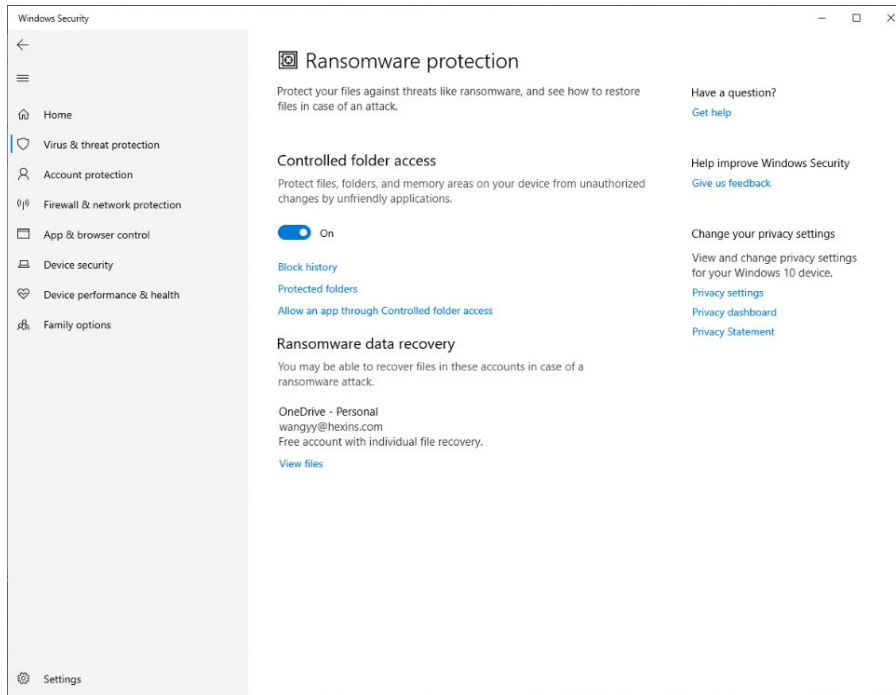
About the impact of the new Defender features

We would like to inform you about the impact of the new Defender features introduced in Windows 10 and Windows 11. Defender now includes a "ransomware prevention" feature, but if Controlled Folder Access is set to "ON" in the "Ransomware Protection Settings" on the Windows Security screen, Optical Disc Archive Software may not function properly.

If this doesn't work, add the following five applications to the "Add allowed applications" list:

Folder : C:\Program Files (x86)\Sony\Optical Disc Archive Software

Application Software: ODAWriterHandler.exe  
 ODAUtility.exe  
 ODAUtility\_Listener.exe  
 ODAUtility\_Helper.exe  
 ODAFiler.exe

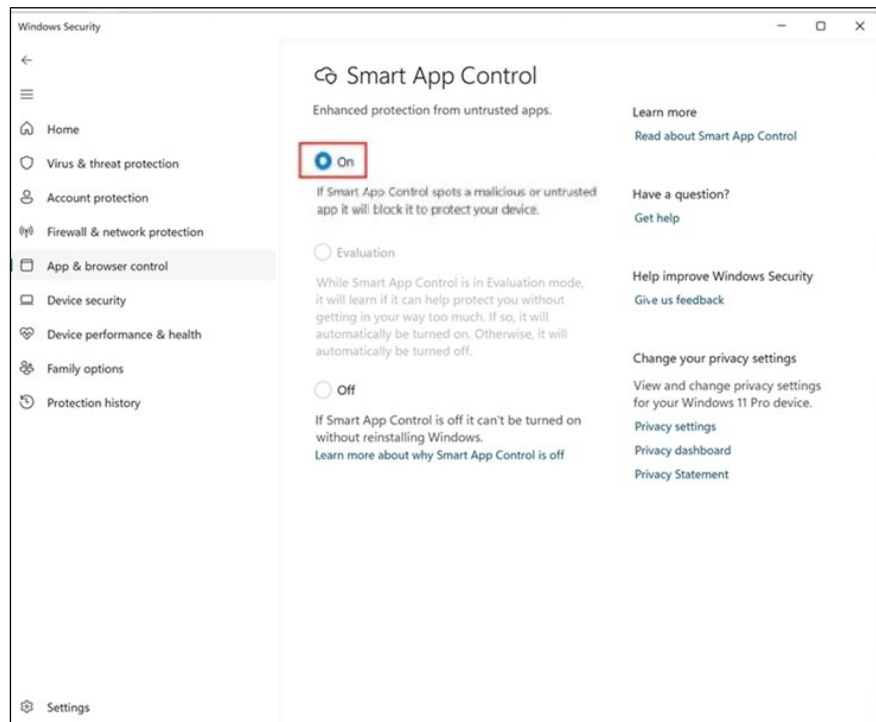
About the impact of Smart App Control (SAC), which was introduced in Windows 11 22H2

If Smart App Control (SAC), which became available in Windows 11 22H2, is set to "On," you may see the message "Parts of this app have been blocked" when launching the Optical Disc Archive Utility or Filer application. This occurs when SAC is unable to check the app's digital signature on the

cloud.

If the message "A portion of this app has been blocked" is displayed,

- You can use the software by connecting to the Internet.
- If you want to use the software in an environment without an Internet connection, connect to the Internet, uninstall and reinstall the software once, then restart the Windows OS and verify that the software's Utility application launches without being blocked. From then on, you will be able to use the software without a network connection.
