Optical Disc Archive Software Ver 5.5.3 is released.

[Additional Items in Ver5.5.3]

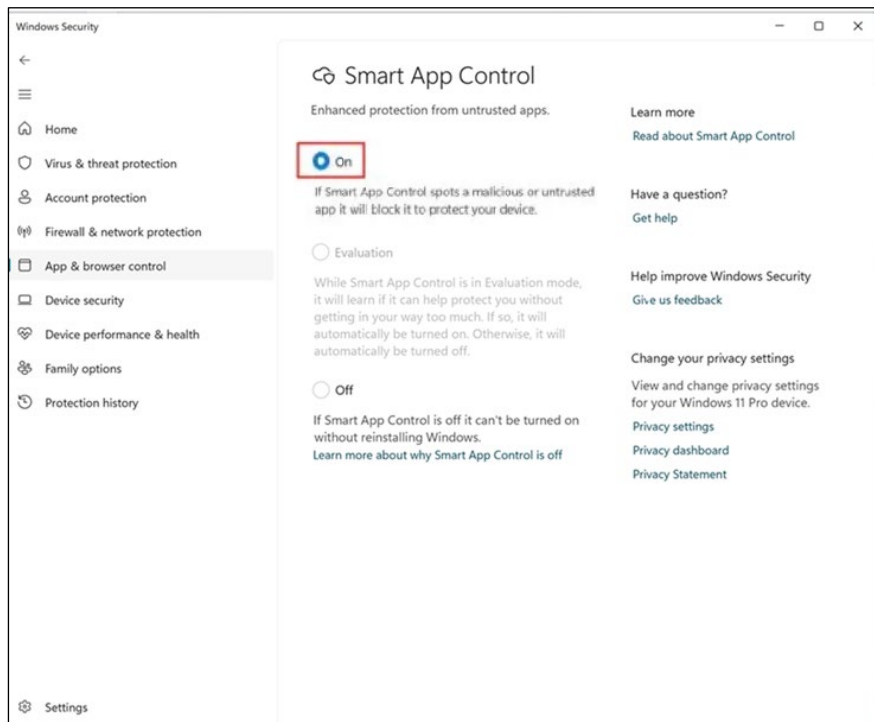
If Smart App Control (SAC), which became available in Windows 11 22H2, is set to "On," you may see the message "Parts of this app have been blocked" when launching the Optical Disc Archive Utility or Filer application. This occurs when SAC is unable to check the app's digital signature on the

cloud.

- You can use the software by connecting to the Internet.
- If you want to use the software in an environment without an Internet connection, connect to the Internet, uninstall and reinstall the software once, then restart the Windows OS and verify that the software's Utility application launches without being blocked. From then on, you will be able to use the software without a network connection.

You can also disable the SAC function itself, but this is a security feature and is not recommended.
