A vulnerability has been identified in the Windows version of Optical Disc Archive Software Ver. 5.5.3; therefore, Ver. 5.5.4 (for Windows) is released.

[Additional Items in Ver5.5.4]

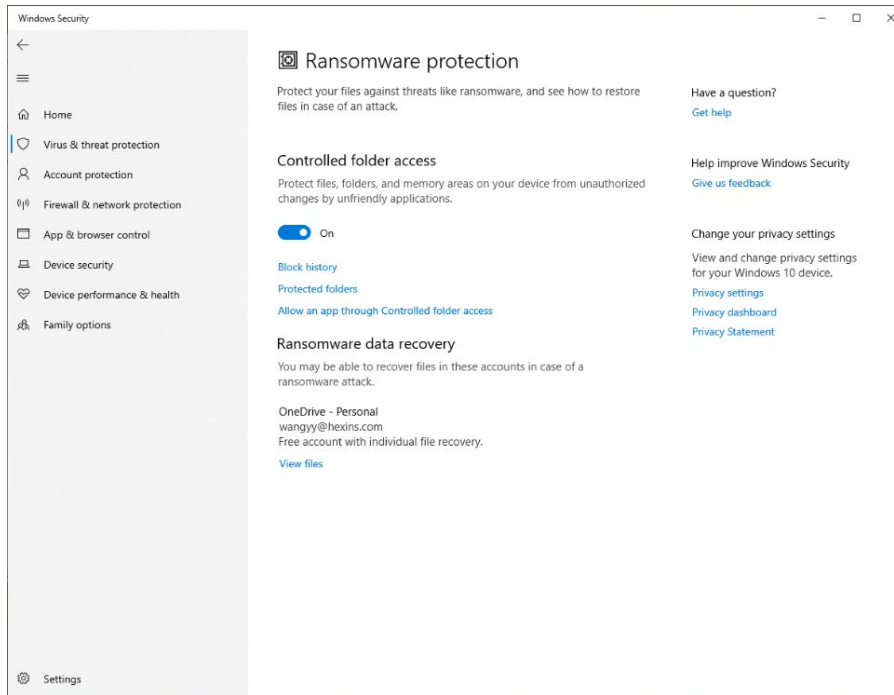
We would like to inform you about the impact of the new Defender features introduced in Windows 10 and Windows 11. Defender now includes a "ransomware prevention" feature, but if Controlled Folder Access is set to "ON" in the "Ransomware Protection Settings" on the Windows Security screen, Optical Disc Archive Software may not function properly.

If this doesn't work, add the following five applications to the "Add allowed applications" list:

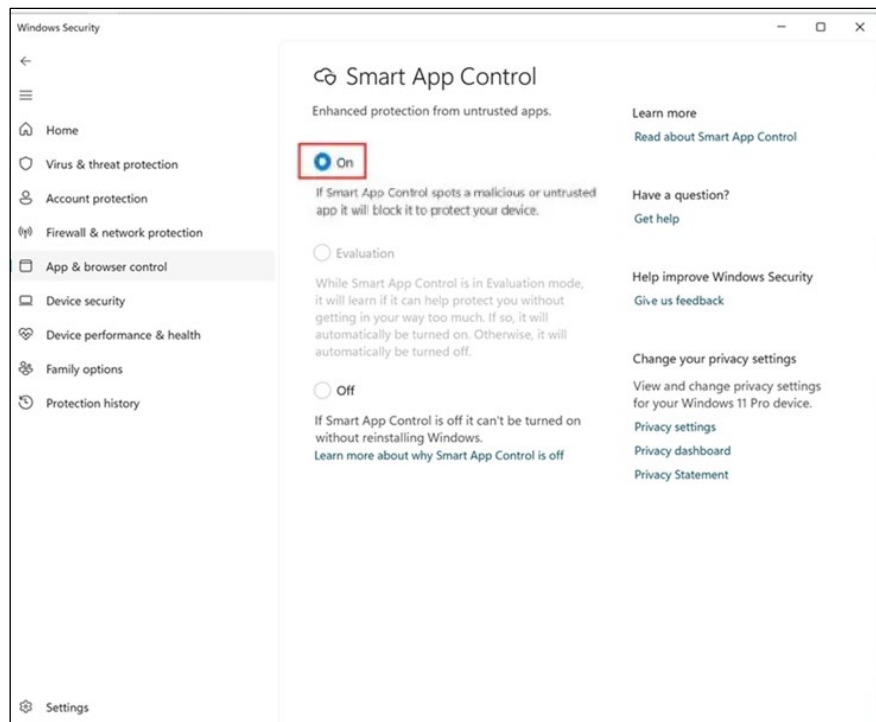
If Smart App Control (SAC), which became available in Windows 11 22H2, is set to "On," you may see the message "Parts of this app have been blocked" when launching the Optical Disc Archive Utility or Filer application. This occurs when SAC is unable to check the app's digital signature on the

cloud.

- You can use the software by connecting to the Internet.
- If you want to use the software in an environment without an Internet connection, connect to the Internet, uninstall and reinstall the software once, then restart the Windows OS and verify that the software's Utility application launches without being blocked. From then on, you will be able to use the software without a network connection.
